City of Escondido Channel Maintenance Activities

Final Supplemental Mitigated Negative Declaration

Case No. ENV 20-0004
State Clearinghouse No. 2012121063
(Previous Case File No. ENV 12-0001)

December 2020

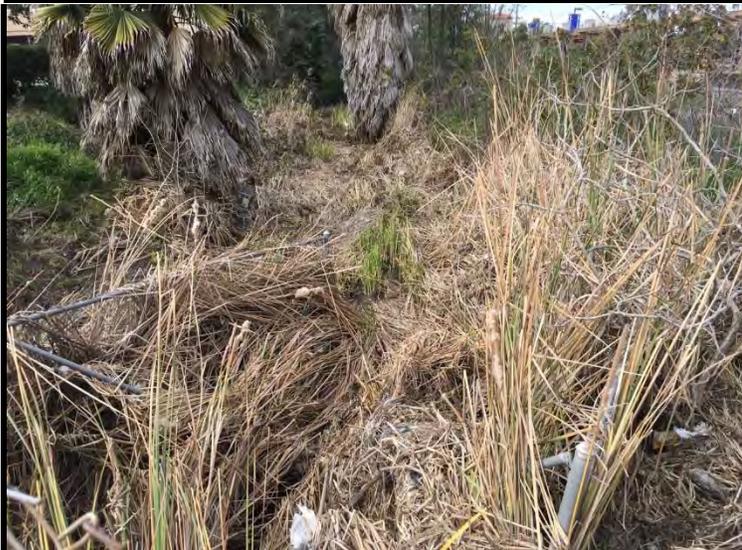
Representative Photograph 1. Facing NW. Coastal and Valley freshwater marsh within portion of channel on west side of Valley Center Parkway.

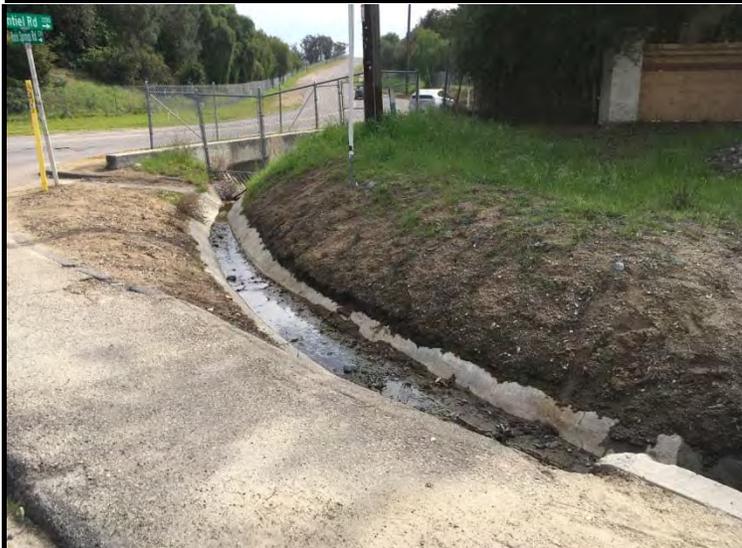
Representative Photograph 1. Facing E. Concrete-lined channel at downstream end

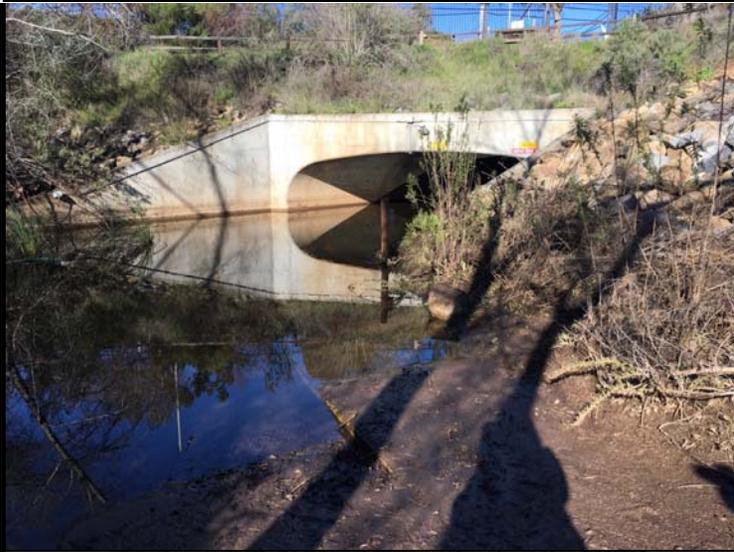
Representative Photograph 1. Facing NW. Large box culvert outlet at upstream portion of channel.

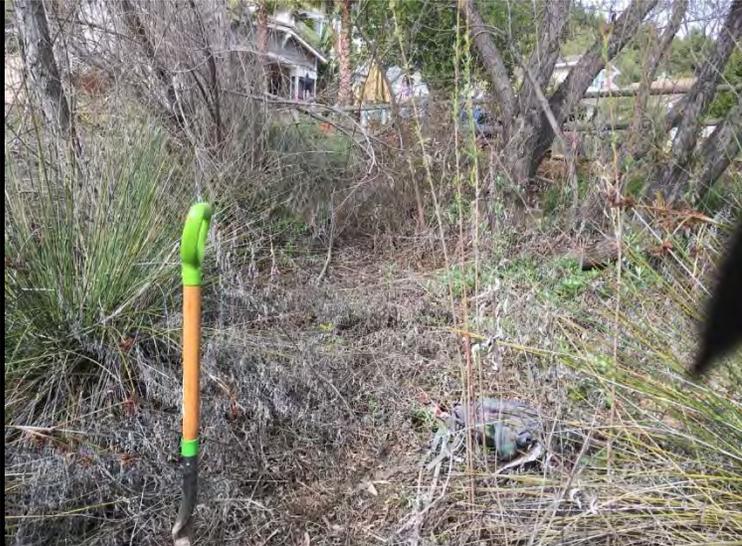
Representative Photograph 1. Facing N. Sample Point 1 within the wetland areas just downstream of the outfall structure.

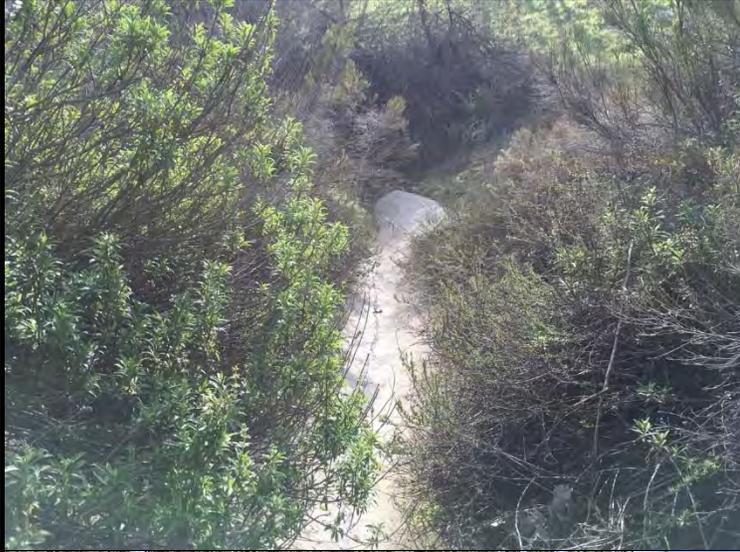
Representative Photograph 1. Facing SE. Concrete-lined channel facing downstream

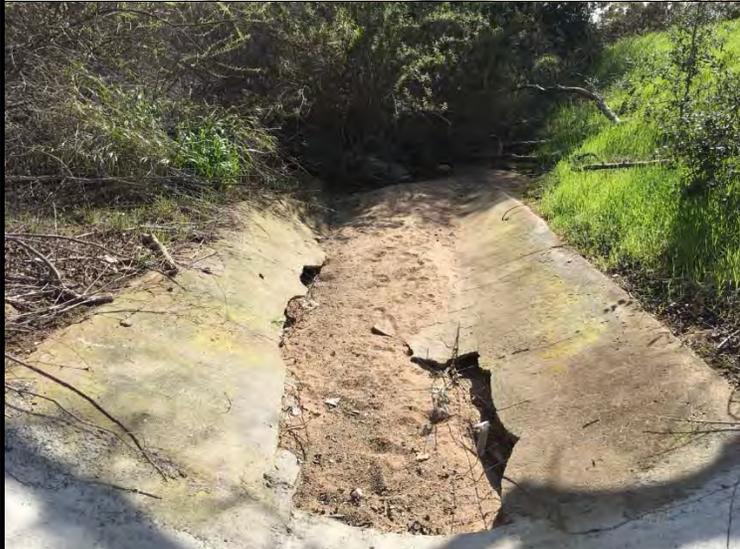
Representative Photograph 3. Facing NW. Portions of concrete is broken and in need of repairs.

| Facility ID | Site Name | Lining Type | Maintenance Footprint | Maintenance Activities | Staging and Access |
|---|---|---|--|--|---|
| H-18 | Kit Carson Bike Trail | Concrete | Full Site Concrete Channel | <p>Remove accumulated sediment and vegetation within Concrete Channel</p> <p>Portion of concrete is broken and requires repairs.</p> | <ul style="list-style-type: none"> Equipment/temporary spoil piles within trail/disturbed areas. A bobcat will drive to the downstream end of the concrete channel and push accumulated sediment upstream to temporary spoil pile location. Native tree trimming as needed to allow equipment access in channel. |

The City proposes to include the repairs of existing concrete aprons and/or concrete-lined drainages as part of the RGP. Repairs would include minor repairs to segments of concrete-lined channels or riprap-lined segments that would not result in the modification of the character, size, or scope of the original fill design. Additionally, these repairs would be limited to either current or new RGP sites. Larger drainages, such as Indian Wells or Escondido Creek, would not be included/covered.

Only one facility location, H-18 Kit Carson Bike Trail, is currently noted as needing repairs to a segment of its concrete channel. However, the City would like the ability to complete these types of repairs to any hardscape facility included in the RGP.

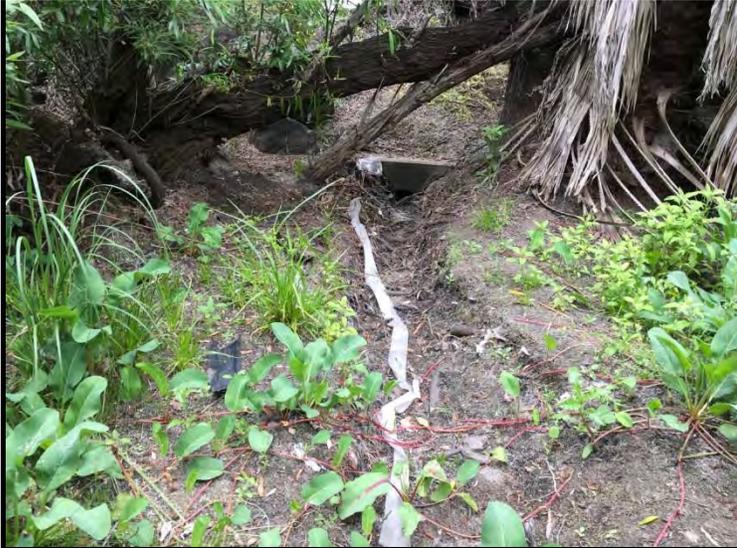
Representative Photograph 1. Facing N. Outfall within wetlands that will be maintained.
